# Manhole Inspection Summary

Manhole # S02WW1008MH

**Location** Address: **3701 FORDS LN** Cross Street: **FIELDCREST RD**

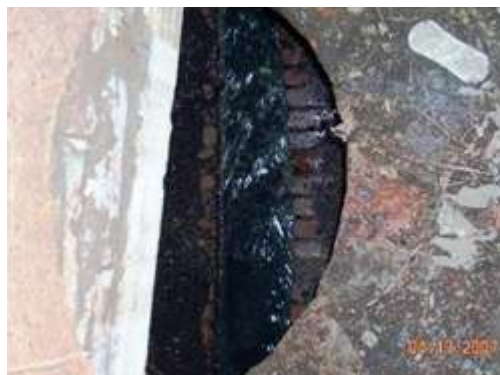
Comments **Revisited 4/17/07 by CH, JJ - We observed heavy clear flow - see Top View photo. This MH's Adjustment is offset vs. the Corbel and the Barrel. The I6 pipe seal is not flush to the pipe.**

Evidence of surcharge - Bench debris.  
Channel debris.

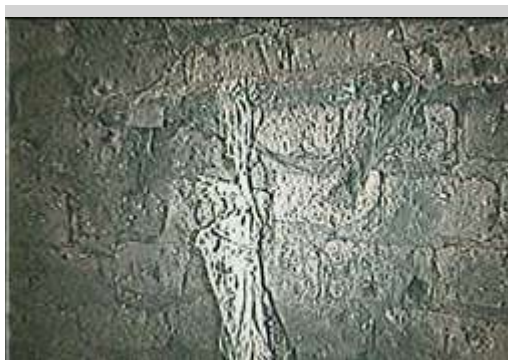
Evidence of surcharge

Barrel deterioration. Corroded step.

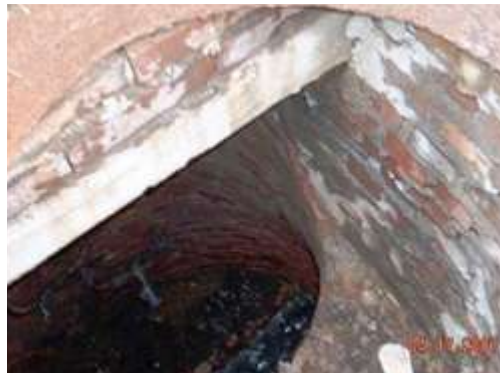
Defect

Frame leaks. Adjustment deterioration.  
Adjustment, Corbel and Barrel infiltration.  
Corroded steps.

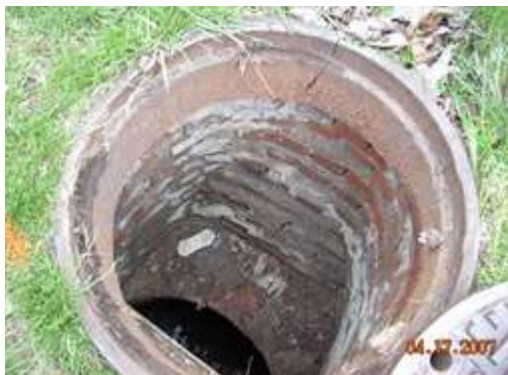
Defect

Frame leaks. Cracked frame. Adjustment  
deterioration and infiltration.

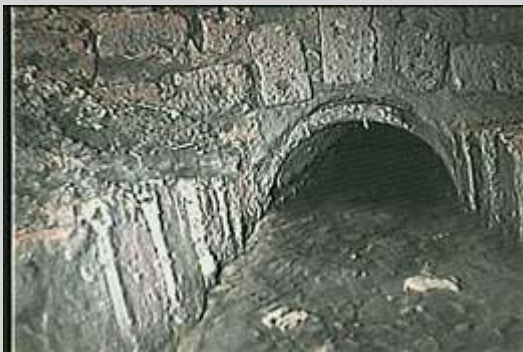
### 8 in. Circular Gravity Sewer Pipe Out @ 12 O'Clock

Barrel deterioration and infiltration. Channel deterioration.

Infiltration: **Evidence** Pipe Seal Cond: **Unknown**

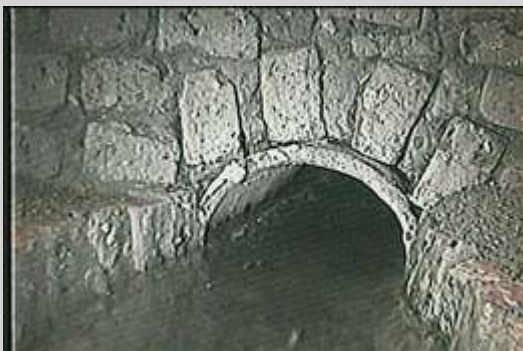
### 8 in. Circular Gravity Sewer Pipe In @ 6 O'Clock

Infiltration: **Evidence** Pipe Seal Cond: **Unknown**
